**Subarunet Announcement**

**UPDATE Safety Recall/STOP SALE: WRI-23 Stop Lamp Switch Adjustment**

Subaru of America, Inc. (Subaru) is initiating a new safety recall and stop sale for certain 2023 model year Impreza vehicles that may contain a stop lamp switch that was improperly adjusted during assembly.

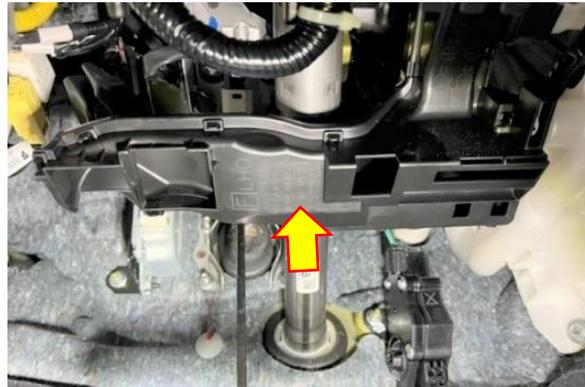
**STEP 1:** Remove the left front footwell air duct.

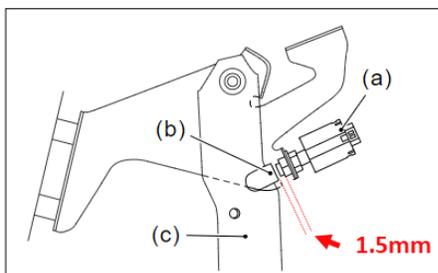
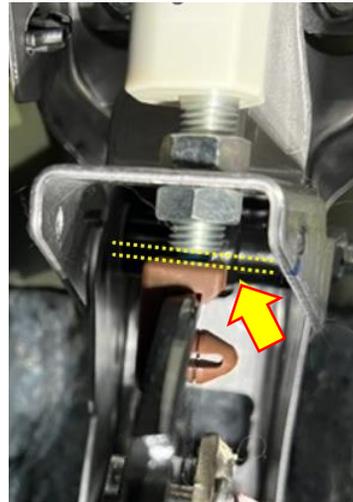
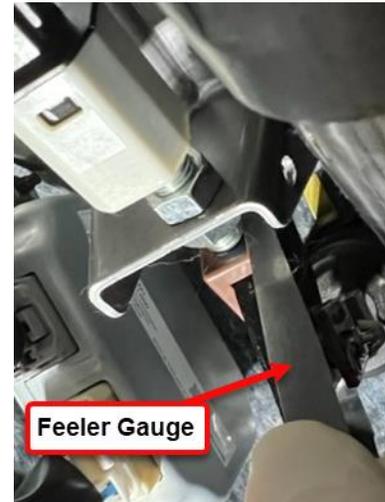
- (a) Stop light switch
- (b) Stopper
- (c) Brake pedal

During the manufacturing of the brake pedal assembly, the brake lamp switch may not have been appropriately adjusted to allow the specified gap between the switch and the stopper. This potential condition may cause the brake lamps to illuminate without application of the brake pedal.

**STEP 2:** Using a feeler gauge, check the switch plunger extension length between the stop lamp switch threads and the stopper section of the brake pedal.

**The plunger portion of the switch should extend between the stopper section of the brake pedal and the stop lamp switch threads 1.5mm (0.06 in) in length.**

- If the plunger extension length found is is the specified value, then no further service procedures are required. Reinstall the left front footwell air duct.
- If the plunger extension length found is not the specified value, an adjustment will be required. Proceed to the adjustment section of this service procedure.

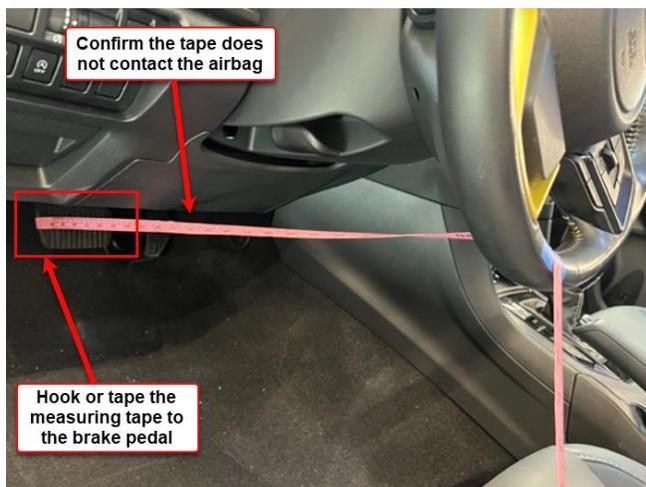
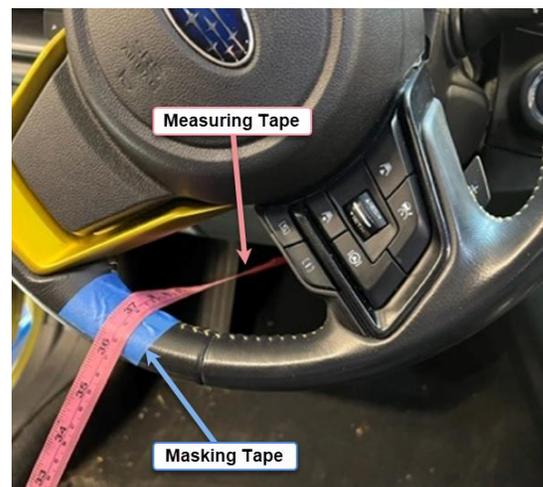
**NOTE:** If needed and to maintain consistency, apply a piece of tape to the brake pedal to be used as a reference mark when making measurements. The end of the measuring tape can also be taped to the pedal itself.

**STEP 4:** Write a reference mark on the taped section of the steering wheel. Make a measurement to the brake pedal in its current position and record it.

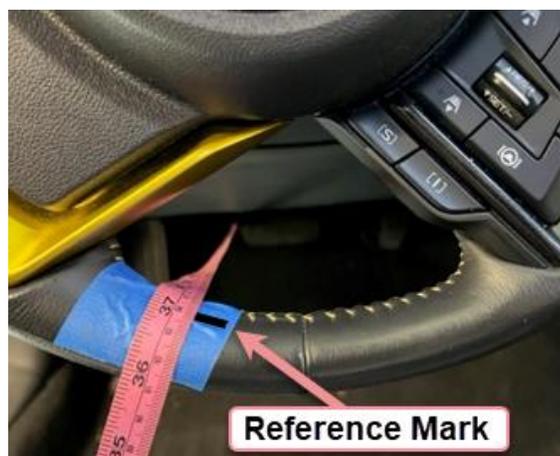
**STEP 5:** Press the brake pedal until the stop lights come on (a second person or the SSM4 with the stop lamp switch PID selected) then measure again to determine the extension of the switch.

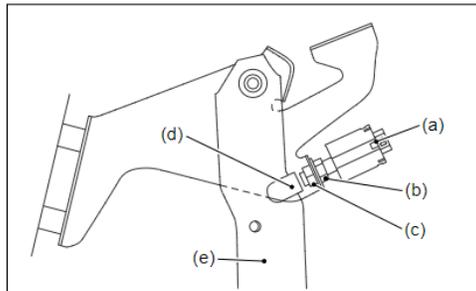
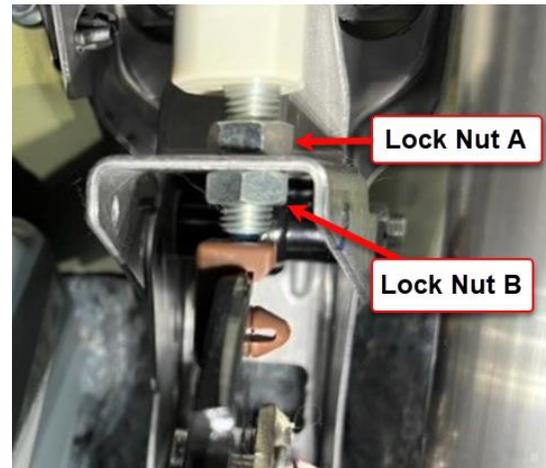
- (a) Stop light switch
- (b) Lock nut A
- (c) Lock nut B
- (d) Stopper
- (e) Brake pedal

**IMPORTANT:** Never adjust the pedal stroke to less than 3mm. Doing so may cause the stop lamp to illuminate without pressing the brake pedal.

**STEP 6:** Loosen lock nut A. Turn lock nut B to adjust the stop lamp switch plunger extension. Turning lock nut B by 90 degrees will adjust the extension length approximately 0.15mm. Once the desired length is achieved, tighten lock nut A to 8nm (0.8 kgf-m, 5.9 ftlbs).
